Outside the Octagon **A Study of Damaged Montreal Stop Signs**

Emma Chait
Department of Anthropology, McGill University

Abstract: Focusing on highly damaged signs, I explore the characteristics of each sign identified as code 3: high, examine vandalism and wear as indicators of human and non-human-induced damage, and ask how language relates to damaged stop signs in Montreal. 83 out of 2816 signs are identified as highly damaged. Both Francophones and Anglophones cause damage to stop signs.

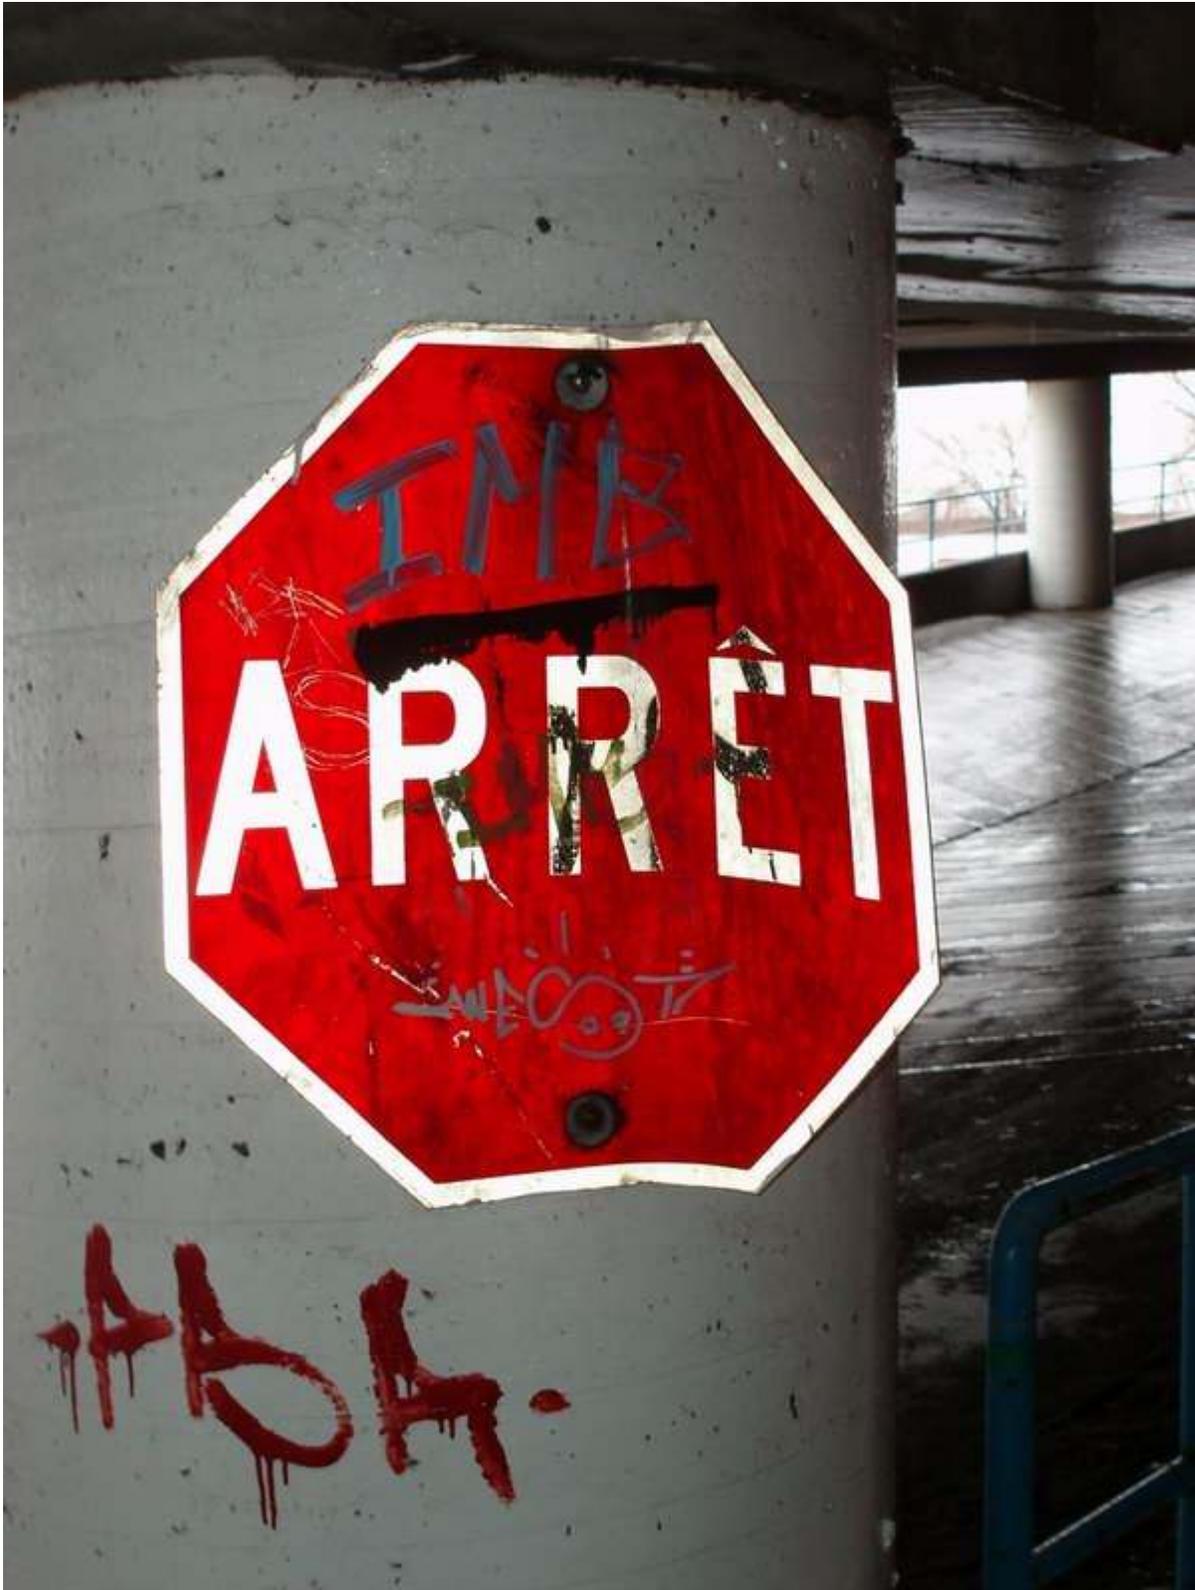
Figure 5: Sign 9-6-e. Example of high vandalism (intentional) and low wear (likely from car exhaust).

Clear evidence of human-induced damage is found in the Cote des Neiges garage with highly vandalised signs. These signs are worn likely by car exhaust and are not exposed to weathering like outdoor signs. Sign 9-8-b (~10% of the sign remains) is found in the garage and is likely to be so extensively damaged because of human activity. The clean-cut edges indicate intentional damage. The entire sign was not removed, however. Since part of the sign remains, it still seems to be required there. This sign should be replaced as soon as possible.

9-6-b	472	Arrêt. Scratched around edges. Pulled into middle from both sides.
9-6-d	474	Arrêt. Scratches around edges. Right side pulled forward.
9-6-e	475	Arrêt. Left side pulled forward. Heavy vandalism. "S" scratched between "A" and first "R".
9-7-c	482	Arrêt. Left side pulled forward off garage wall.
9-8-b	484	Arrêt. Only right side of "T" visible. Only about 15% of sign sill attached to support.
9-8-f	487	Arrêt. Sign warped in many directions. Right side pushed back, top left corner pulled off wall.
9-9-f	495	Arrêt. Right side pulled off wall. Scratch down length of sign between first "R" and second "R".
9-15-1	515	Arrêt. Right side of sign pushed back.
9-39-1	586	Arrêt. Large dents around bolts.
11-1-5	48	Stop. Both sides pulled in to center. Lower right side pulled in most dramatically with large scratches on face.
11-13-1	84	Stop. Upper left and lower right pushed back. Large scratch down middle of sign between "T" and "O".

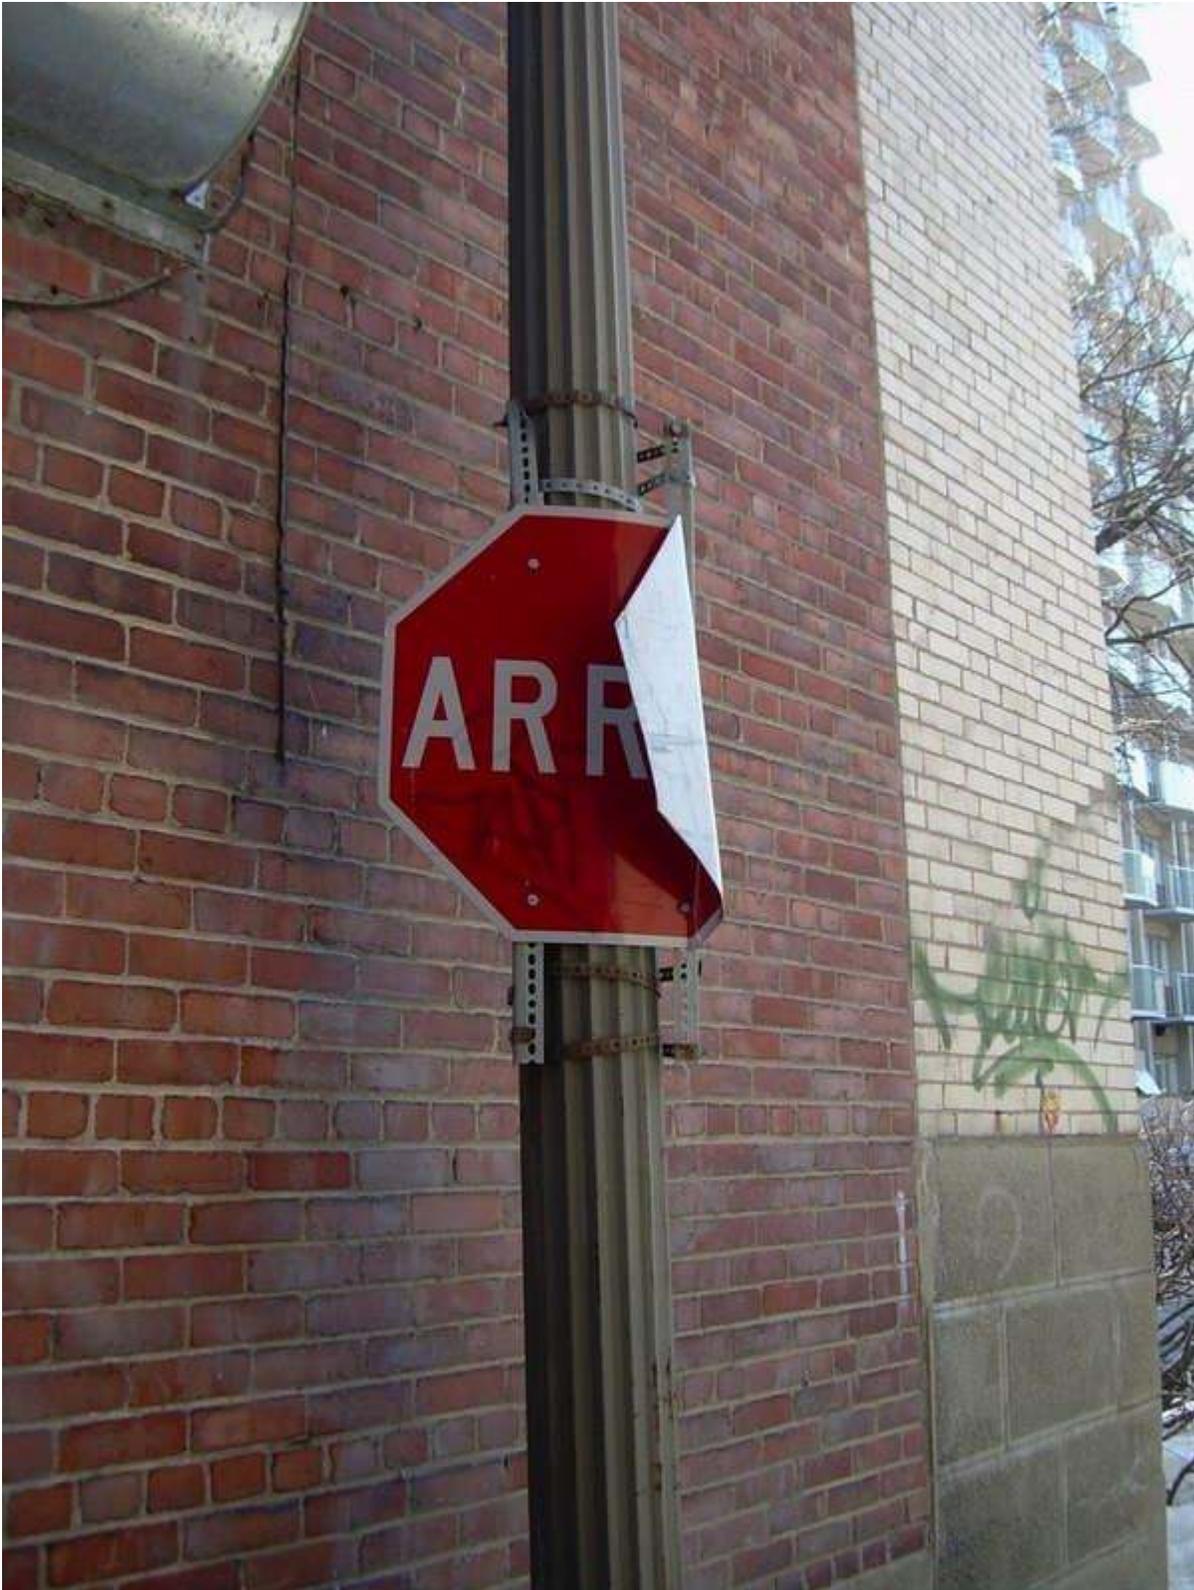
Figure 6: Sign 2-23-8. One of most highly damaged signs.

Specimen	Photo	Description of Damage (language noted)
1-43-4	1433	Arrêt. Lower half of sign pulled forward from under the back support. Two dents on rights side under the "A".
2-23-8	134	Arrêt. Entire left side of sign completely folded over. "E" and "T" invisible. Back of sign visible.
2-27-7	145	Arrêt. Right side pushed back. Crack between two "R"s.
3-14-8	260	Arrêt. Left side pulled forward but all letters still visible.
3-16-3	265	Arrêt. Lower half of sign pulled forward, worse on right side near "A" and first "R".
3-24-7	461	Arrêt. Heavily vandalized sign.
3-35-3	712	Arrêt. Two scratches from upper left face to lower right.
3-40-1	729	Arrêt. Half of the first "R" is scratched out.
3-49-3	Missing	
3-52-7	758	Arrêt. Heavily vandalized.
4-2-8	1172	Arrêt. Top and lower left side and curled back. "T" still visible. Scratch on right side and near top of "A".
4-4-3	1178	Arrêt/Stop. Pulled forward from support. "ARRE" and "STO" more forward than "T" and "P".

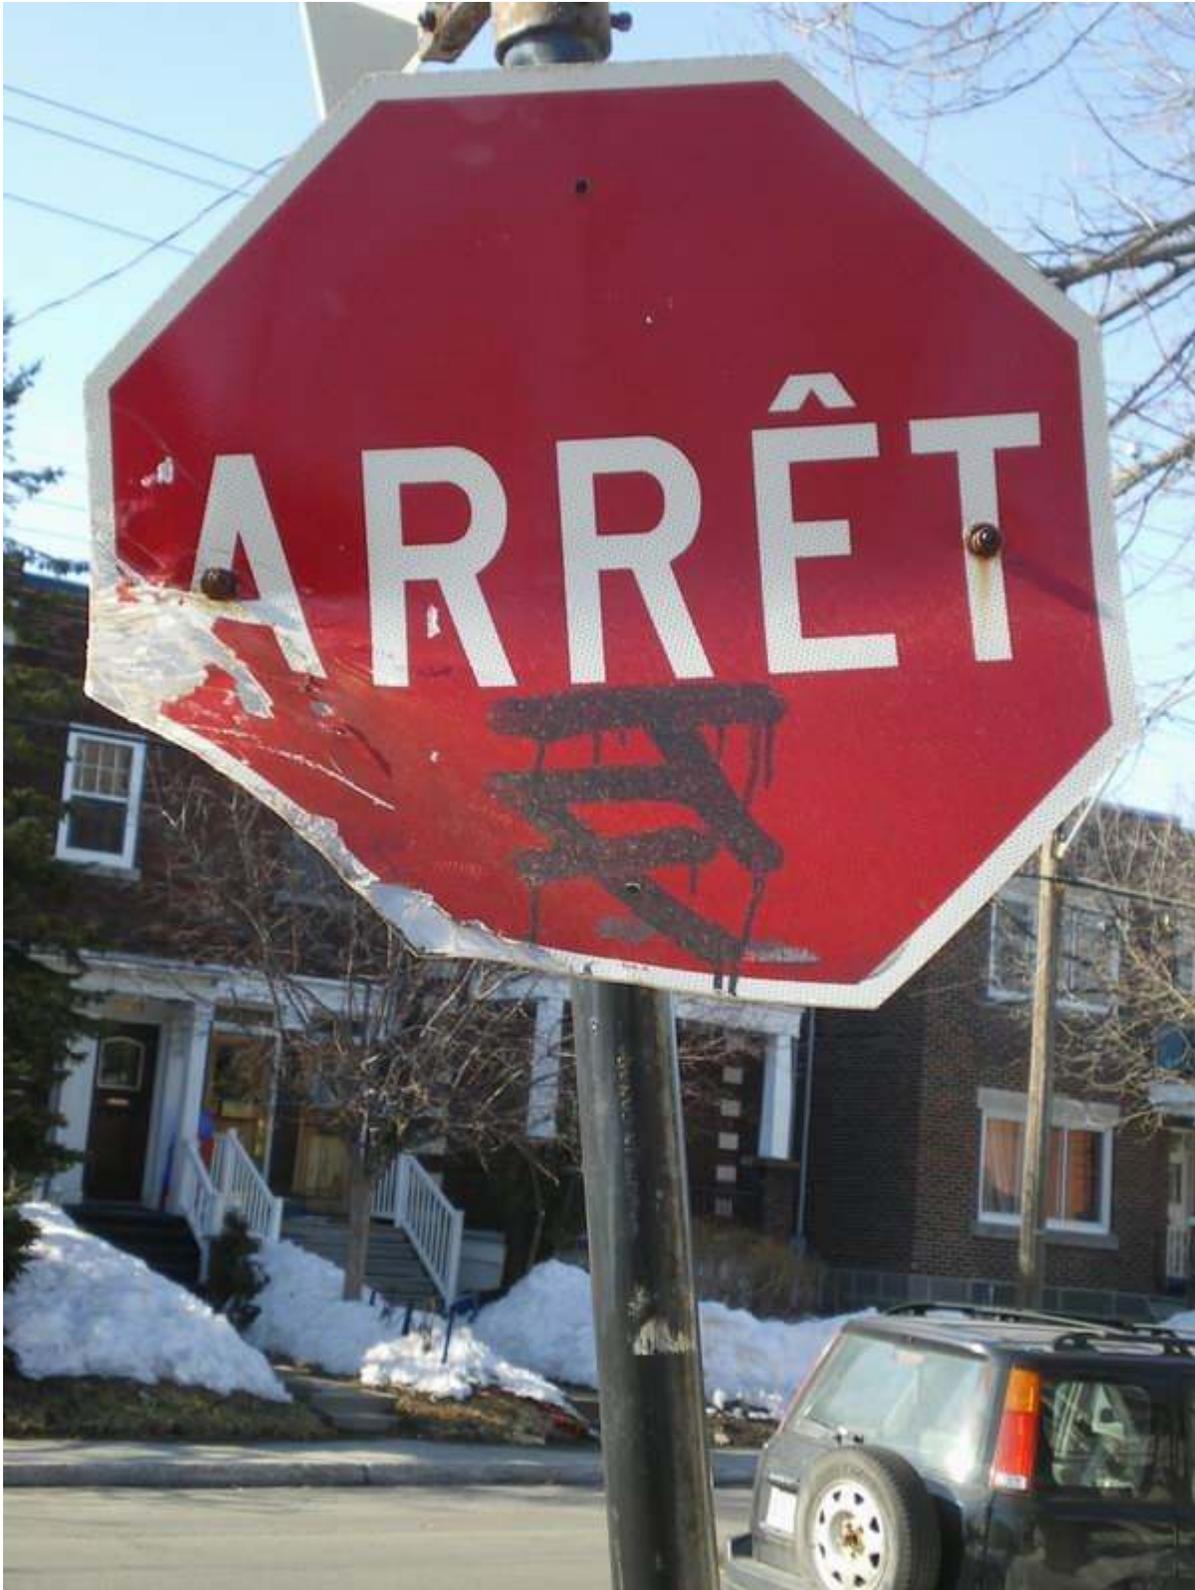
Figure 7: Sign 23-15-7. One of the most highly damaged signs.

Back	3--40--1 12--14--8	Plateau West	3 stickers. White paint writing on lower corner.
Vandalism 1: Low			
Front	3--14--8	Ville Marie	1 sticker.
	3--35--3	Ville Marie	1 sticker on 2-way arret sign.
	8--3--2	West	1 sticker.
	8--30--3	West	Piece of string on lower part.
	8--55--5	West	Tan writing.
	9--6--b	CDN	Paint or car exhaust?
	12--13--3	West	1 sticker.
	12--19--7	West	White writing.
	12--28--5	West	1 sticker.
	14--28--4	CDN	1 sticker.
	15--12--7	CDN	Many scratches.
	23--15--7	NDG	"F", "T".
	28--26--4	NDG	1 sticker.
	29--46--7	CSL	1 sticker.
Back	1--43--4	Plateau	1 sticker.
	7--27--1	Ville Marie	1 sticker.
	8--30--3	West	No photo
	12--12--7	West	No photo
	12--20--7	West	Handwriting.
	12--24--7	West	1 removed sticker.
	17--15--7	CDN	Writing.
	20--9--4	NDG	2 stickers. Intentional damage.
	23--15--7	NDG	1 sticker.
